title: IMPROVED HARDWARE AND TECHNIQUES FOR
MAINTENANCE AND REPAIR OF SPLIT-PIPE-
PROTECTED CABLES

author: R. L. Brackett and W. R. Tausig

date: August 1977

CIVIL ENGINEERING LABORATORY

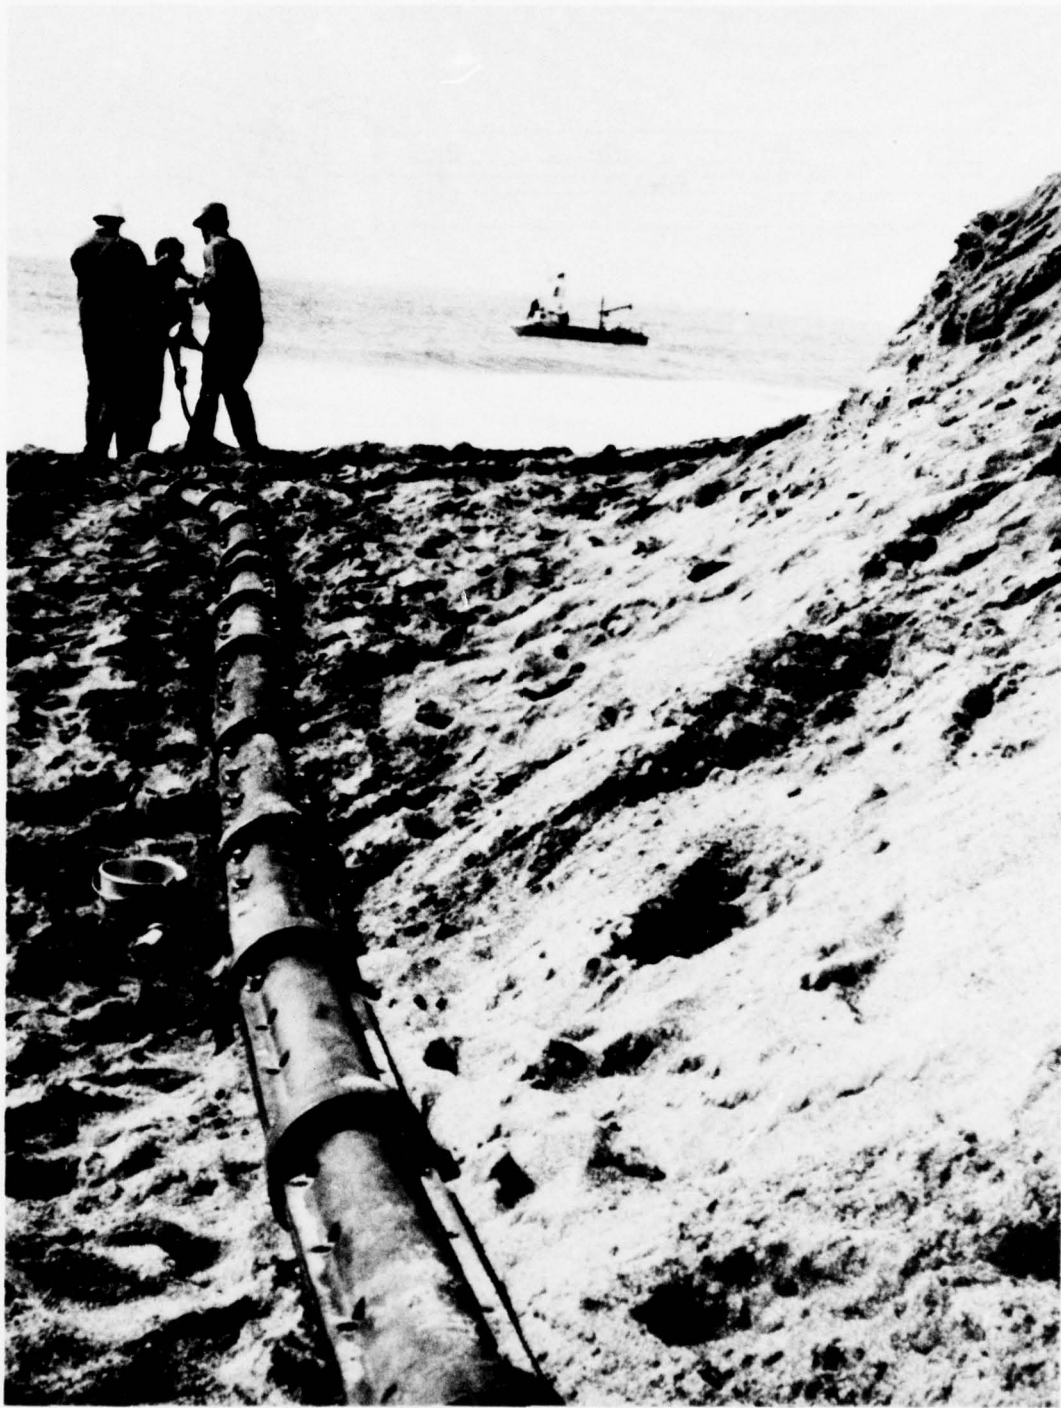
Figure 1. Split pipe cable protection system.

The U. S. Navy currently maintains and operates numerous underwater power and signal cables. Most of these cables utilize split pipe systems (Figure 1) to protect the cable from damage in the surf zone and when crossing exposed, rocky seafloors. Past experience has shown that the hardware used to install the split pipe system lacks the reliability and maintenance-free operation required for the operational life of these cable protection systems (up to 20 years).

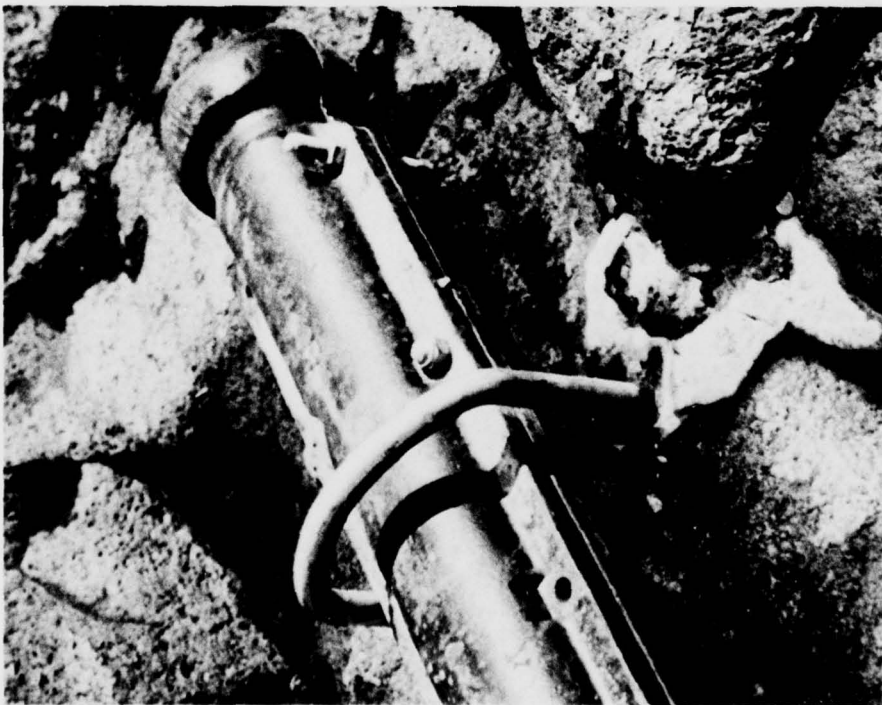
Figure 3. Grouted U-rod.

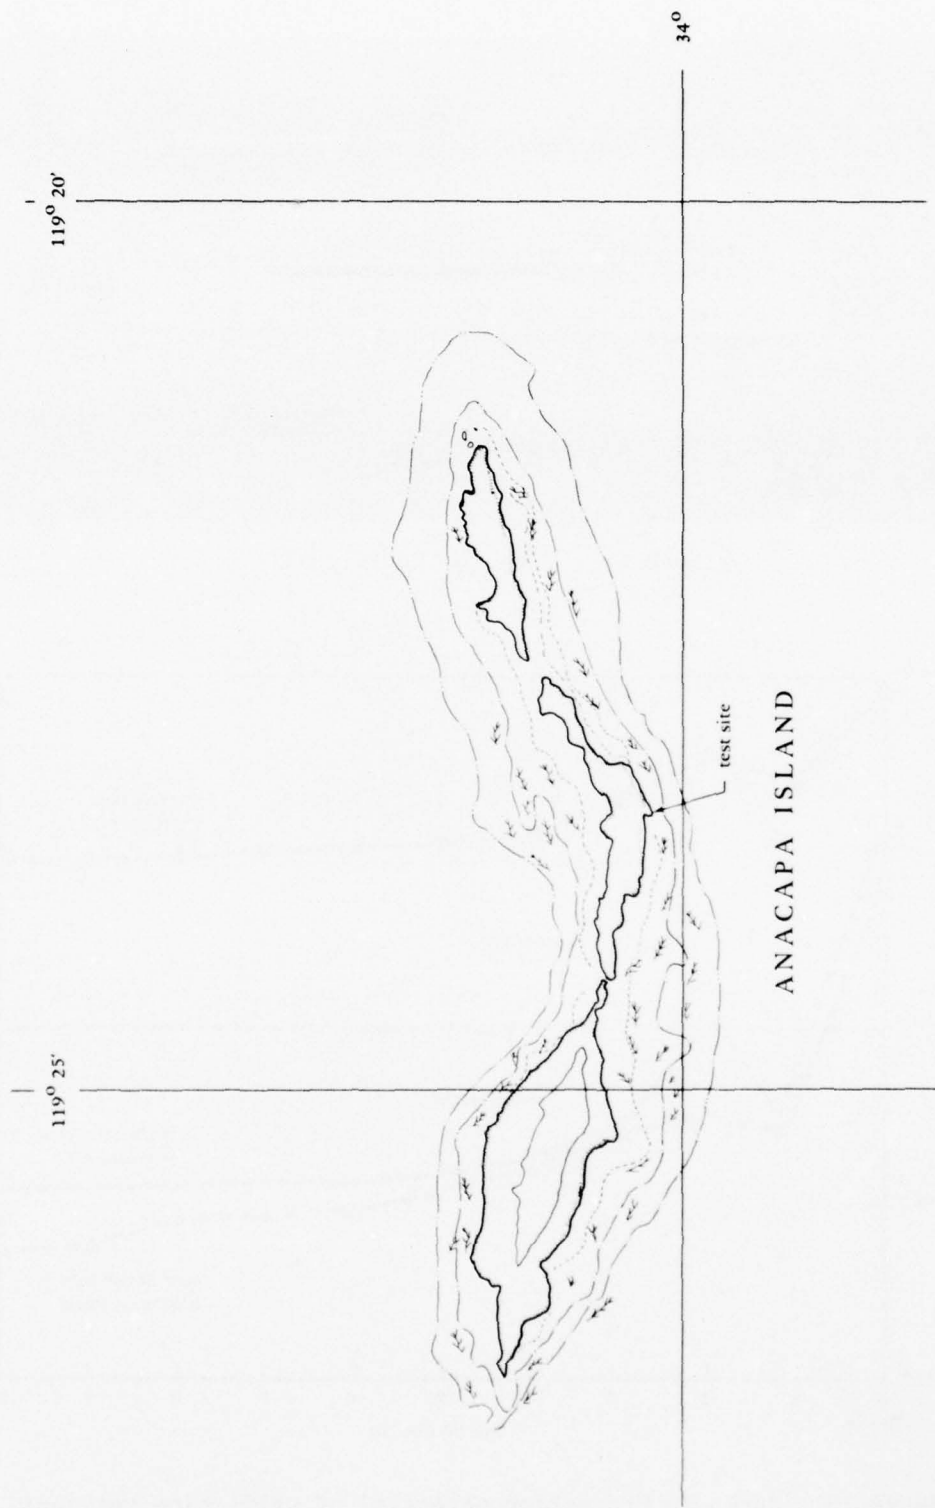
Figure 16. Anacapa test site.

The selected site is located on the south side of Anacapa Island at coordinates 34°0'15"N latitude, 119°23'30"W longitude (Figure 16). After preliminary selection, the site was surveyed, and the following conditions were found:

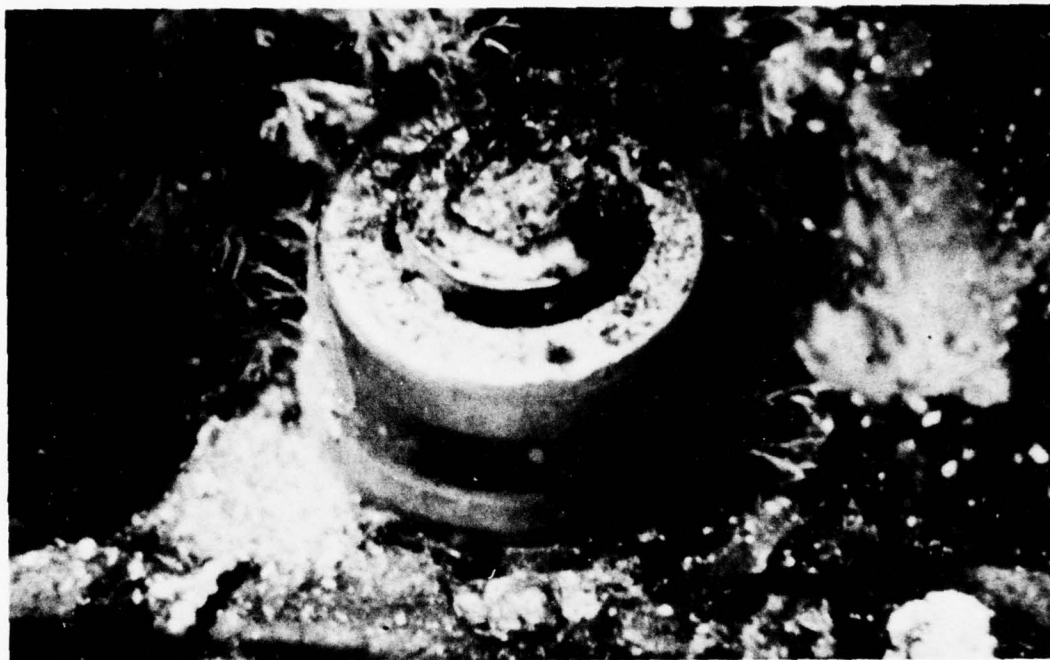
Figure 24. Close-up photo of fasteners (protected).

Galvanic potential readings were obtained with an underwater voltmeter; the results are presented in Figure 22. Because of the numerous broken jumpers and disconnected anodes, only sections 45 through 78 are being protected. Figures 24 and 25 are representative closeup photos taken of fasteners in the protected and unprotected areas, respectively.
